Degradation of a Thrust Bearing in a Lift Pump on an Electromotor Offshore Platform

A. AGHAJANI, *Subsea R&D Center, Isfahan University of Technology, Isfahan, Iran*

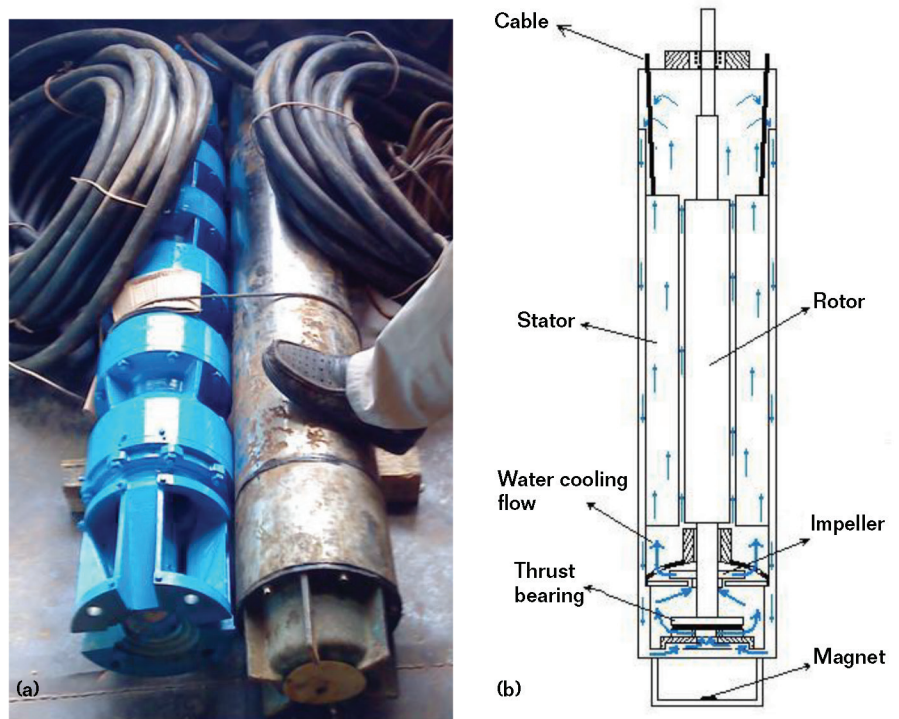
FIGURE 1 (a) The electromotor for a lift pump used on an offshore platform. (b) A cross section of the electromotor is illustrated in the diagram.

Specifications for a high-power lift pump electromotor are shown in Table 1. A photograph of a lift pump is shown in Figure 1(b) in Figure 1(a), and a cross-section diagram is shown. The electromotor is cooled by an internal water cooling system for the lift pump. Water is sucked into the internal upper area of the electromotor, pulled through a double-layered electromotor body by an impeller attached at the end of a rotor, and pumped upward through stator windings and the space between the rotor and stator. All motor bearings are lubricated and cooled by the circulating water, which absorbs heat from

At the end of the electromotor, there is a water-lubricated thrust bearing (located near the bottom of the cross section in Figure 1[b]). The thrust bearing includes a circular carbon pad that rotates on tilting stainless steel (SS) pads, or segments (Figure 2), located on a carrier. The tilting movement of the SS segments facilitates the formation of a water film between the carbon pad and SS segments that helps to reduce their wear.¹⁻³ The polished surfaces of the carbon pad and SS segments, combined with the formation of a water film, produce a very low friction coefficient. This allows the electromotor rotor to rotate easily and vertically on the surface of the thrust bearing.

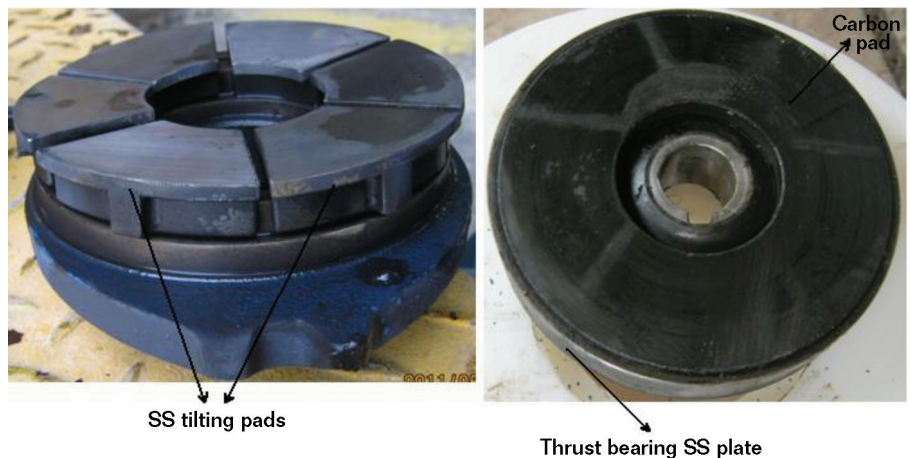
FIGURE 2 The SS pads and carbon pad used in a thrust bearing.

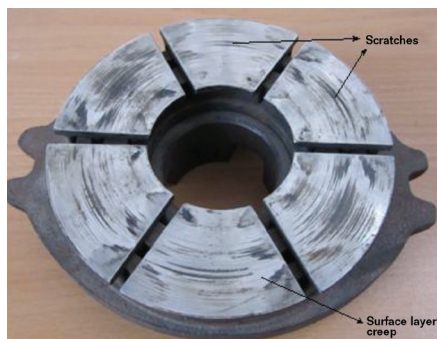
When the pressure of the carbon pad on the SS pads becomes sufficiently high, surface creep occurs on the SS pads and the smooth surface deteriorates. The resulting roughening of the surface is shown in Figure 3. A sudden change in output pressure of the pump also can cause the carbon pad to produce a hammer impact on the SS pads, which removes the water film and aggravates surface damage of the SS pads.

FIGURE 3 The SS pads of the thrust bearing show surface layer creep and a rough surface.

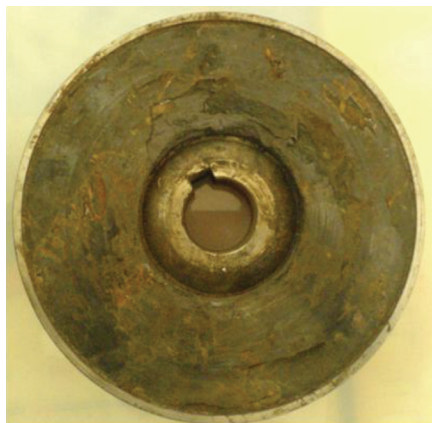
When fatigue and creep change the polished surface of the SS pads to a rough surface, the SS pads scratch the carbon pad surface. As shown in Figure 4, carbon particles resulting from the worn SS pads scratching the carbon pad fill surface roughness recesses on the SS pads, which further increases the friction between the carbon and SS pads. Once the SS pads become rough, they will damage the surface of the carbon pad, as shown in Figure 5.

FIGURE 5 The rough and damaged surface of a thrust bearing carbon pad.

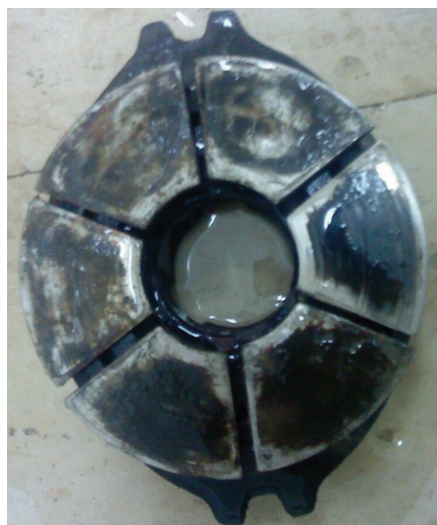
FIGURE 4 After the surface of SS segment becomes rough, carbon particles from the carbon pad fill in roughness voids and produce additional friction-related wear.

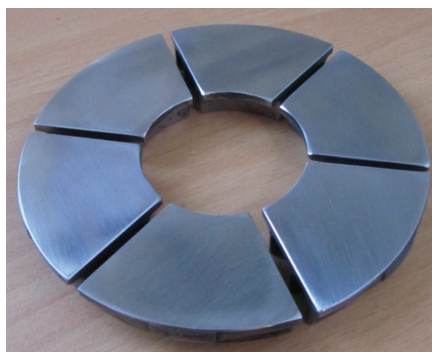
FIGURE 6 The finished surface of the SS pads after machining and polishing.

To investigate the causes of the problem, the electromotor was disassembled, which revealed the badly damaged thrust bearing. To repair surface creep damage on the thrust bearing SS pads, 1 mm of surface area was removed by machining and the new surface was highly polished, as shown in Figure 6. The electromotor was then reassembled, started, and tested in 1 MPa pressure. As shown in Table 3, after ~15 min, the electromotor temperature reached its steady-state conditions (47 °C and 147 A) and the problem was resolved (seawater temperature was 22 °C).
